#### **ADDENDUM**

## Section 3. Owner of Property

# INVENTORY FORM FOR STATE HISTORIC SITES SURVEY

NAME				
HISTORIC				
George	Pocock House			
AND/OR COMMON				
The Ti	lghman-Ferrare Ho	use		
LOCATION	1			
STREET & NUMBER				
	5741-45 Main	Street		W
CITY, TOWN	Elkridge,		CONGRESSIONAL DISTRI	CT
	Elkildge, _	VICINITY OF	6th	
STATE	Maryland		COUNTY Howard	
CLASSIFIC	CONTRACTOR OF STREET,		110 Wat a	
om room ro				
CATEGORY	ORY OWNERSHIP STATUS		PRESENTUSE	
XDISTRICT	PUBLIC	_OCCUPIED	AGRICULTURE	_MUSEUM
BUILDING(S)	XPRIVATE	_UNOCCUPIED	COMMERCIAL	PARK
STRUCTURE	ВОТН	WORK IN PROGRESS	EDUCATIONAL	2PRIVATE RESIDEN
SITE	PUBLIC ACQUISITION	ACCESSIBLE	ENTERTAINMENT	RELIGIOUS
OBJECT	IN PROCESS	_XES: RESTRICTED	GOVERNMENT	SCIENTIFIC
	BEING CONSIDERED	YES: UNRESTRICTED	INDUSTRIAL	_TRANSPORTATIO
		NO	MILITARY	_OTHER:
OWNER OF	FPROPERTY		- 11 20 D	601
OWNER OF PROPERTY Tax Map 38, P. 783		Tax Map 38, P. 691		
NAME Mare	garet Tilghman		Florentine Ferra	ro etal
STREET & NUMBER				
574	l Main Street		5745 Main Street	
CITY, TOWN

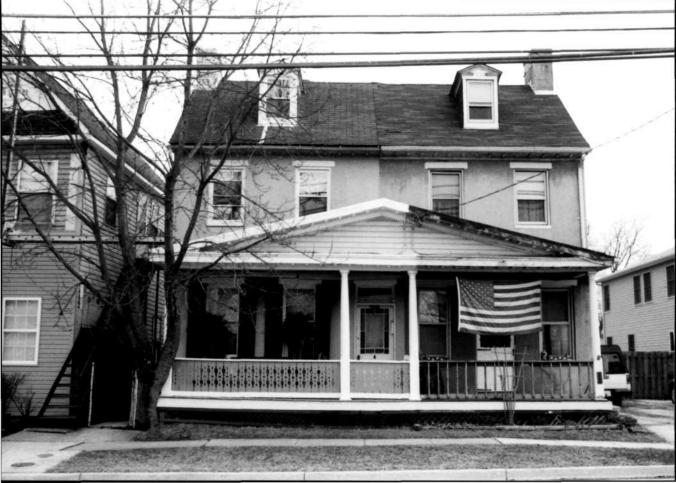
10:319 The Tilghman Ferrare House STATI + 5745 Main St., Elkindye Land by Astonic District Howard County, MD Photo by: Known Hill February 2003-Negotive at MD SHPO North facade #1 2

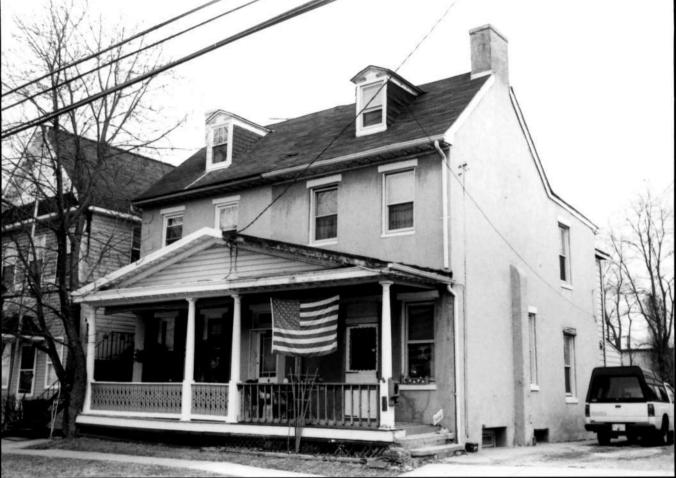
HO.319. The Tilghman Ferraro House 5741+5745 Main St., ENhange Landing Astonic District Howard County, MD Photo by Kastin Hill February 2003 Negative at MD SHPO NW facade

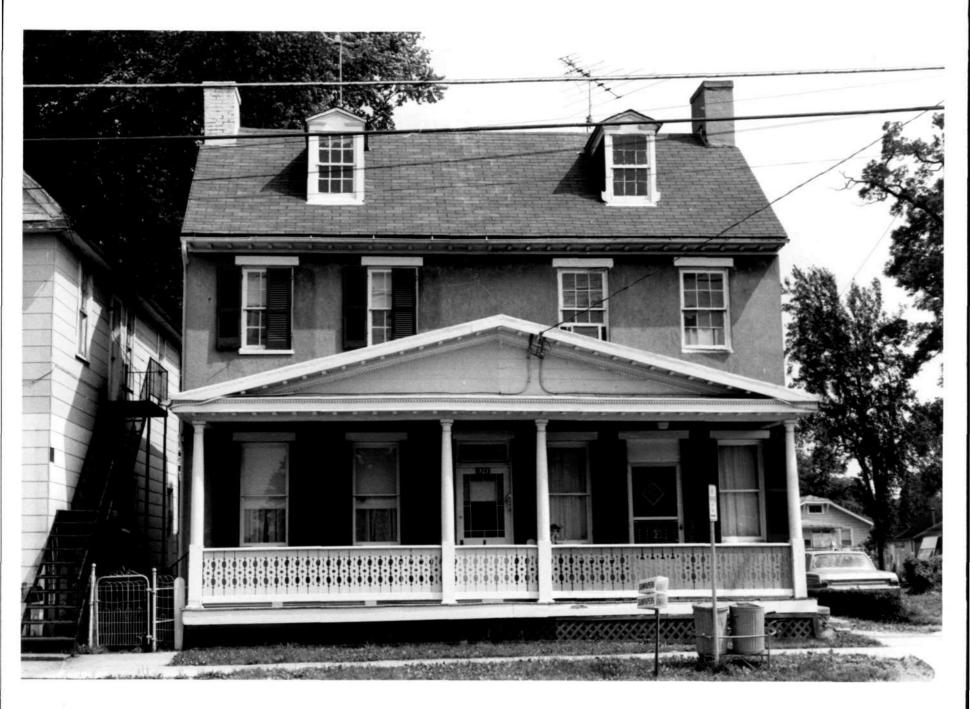
The Tilghman Ferraro House 5741-45 Main St. Elkninge North CB Thompson, ALCP Pecember-1978
